Double block & bleed: understanding a barrier - part 5

Norwegian consultant and valve instructor, Ingolf Fra Holmslet, continues his bi-monthly series of informative articles.

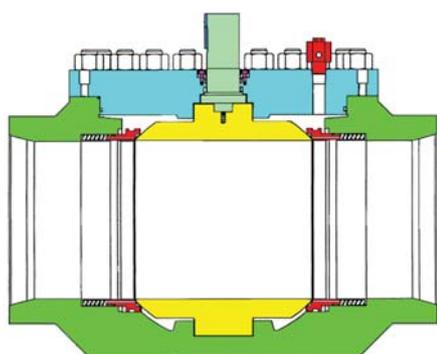
Figure 22.

There was a 36" pipeline valve as illustrated in Figure 22, an ESD export valve on a platform in the Norwegian sector of the North Sea (152 bar gas). The valve was a top entry trunnion mounted ball valve with seats of the self-relief type. It was an in welded valve and there was a major spindle leakage every time the valve was operated.

The leakage stopped around 30 minutes after operation both towards the open and closed positions.
