Six problem valves

The how (and why) of maintenance Part 5

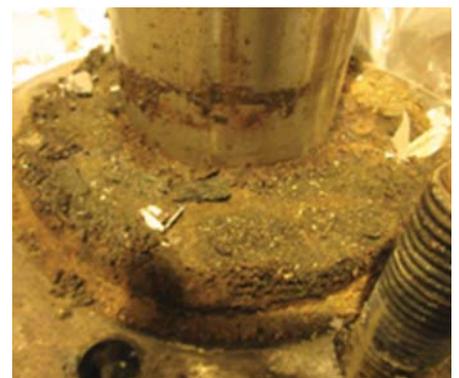
Fig. 22

It is not unusual for the material quality of the valve part not in contact with the media to be of lower quality than the parts in contact with the media. The six valves were all 316, but looking at the valve the gear-adaptor looked like it was made of carbon steel and, as we know, that part is not in contact with the media. When condensation or rainwater falls down between the stem and gear adapter there can be a lot of corrosion if any of the parts are made of carbon steel. Looking at the VDS I could see that the gear-adaptor and the press-gland were made of carbon steel, so my advice in this situation was to keep on producing and take the gear and the gear-adaptor off the valves and control for friction between the gear-adaptor, press-gland and the stem. After taking off the gear and the gear-adaptor we saw what you can see in Figure 22 that clearly shows what it looked like below the gear-adaptor; it was full of corrosion. The image in Figure

When condensation or rainwater falls down between the stem and gear adaptor there can be a lot of corrosion

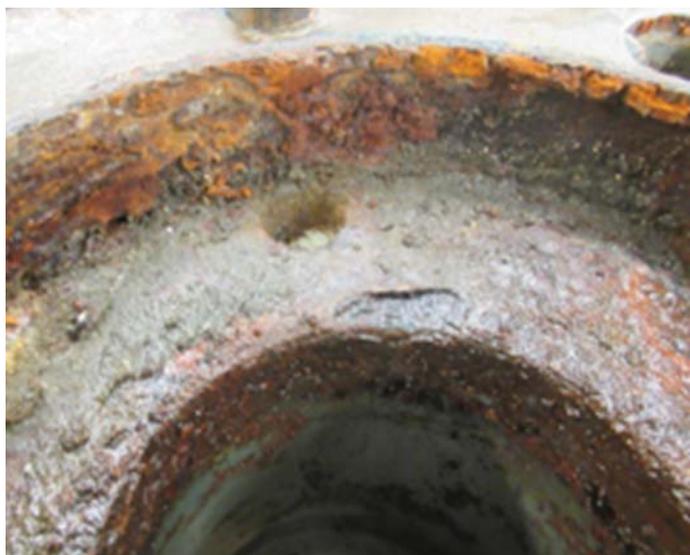
Fig. 23

23 shows the corrosion in the bottom of the gear-adaptor and one also can see in Figure 23, there was a leak indication hole in the bottom of the gear-adaptor which allowed water to leak in between the adapter and the press-gland. Figure 24 shows how it looked like after taking away most of the corrosion on the top of the gland-plate, and Figure 25 shows the corrosion on the inside of the gear-adaptor towards the spindle.

You don't have to be a rocket scientist to understand why the six valves were stuck and impossible to operate. After cleaning

the valves there was no problem operating them with a handle and the whole gear-adaptor was filled with grease from the bottom to the top to prevent the same situation occurring in the future.
